Characterization of Stone and Mortar Decay – Casa Major Pessoa, Aveiro

ABSTRACT: Casa Major Pessoa is one of the most remarkable *Art Nouveau* buildings in the city of Aveiro, a town that is especially well known in Portugal for its heritage representative of this artistic style. This house was private property until recent years and when it became vacant its decay process began, favoured by enclosure and lack of maintenance. Recently, the building, classified as of Public Interest, was bought by the Town Hall in order to create an *Art Nouveau* Museum. The severe degradation present throughout the house and specifically on its richly decorated façades led to a study investigating the state of decay of different materials. Samples were extracted from exterior stone elements, both interior glaze-supporting mortars and exterior mortars. Analysis included x-ray diffractometry (XRD), atomic absorption spectrometry (AAS), and scanning electron microscopy (SEM) performed both in stone and mortars. Results revealed the presence of salts in most samples, with a prevalence of thenardite and gypsum. Their presence can be attributed to the action of maritime aerosol, combined with traffic po

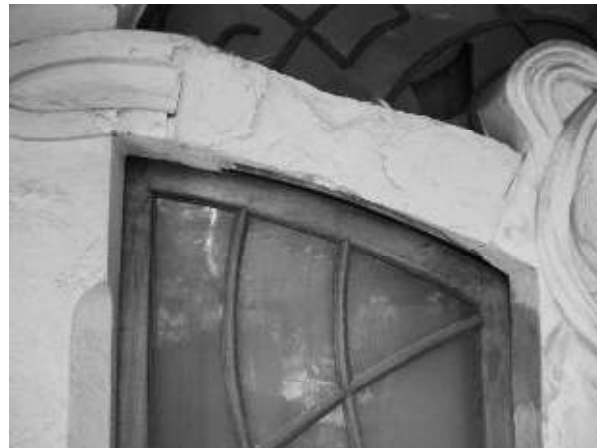
The stone surrounding the main doorway has suffered interventions since its construction, visible in a layer of cement mortar that was executed over part of the stone (Fig. 4). The main pathologies present are identified as scaling (Figs 3 and 4),

Figure 3. Scaling on calcareous stone

- samples of scaled calcareous stone were taken from the front porch representing two main zones: S1 (Fig.3) from areas with no

Analyses show higher discrepancies between the various stone samples. Analysis by x-ray diffraction shows thenardite (Na₂SO₄) as the main mineral in sample S3. In other samples gypsum (or its anhydrous form, anhydrite) is the main mineral associated with the degradation process. Also thenardite co-exists in sample S4, taken from a black crust in the exterior. Mirabilite (Na₂SO₄·10H₂O), a form of hydrated thenardite is present only in sample S3, whilst siderite is present in low quantities in samples S5 and S7.

Substitution of extremely degraded stone is inevitable and consolidation procedures must be considered, although they pose a delicate problem when dealing with calcareous stone (Canas 2003, Rodrigues 2001).

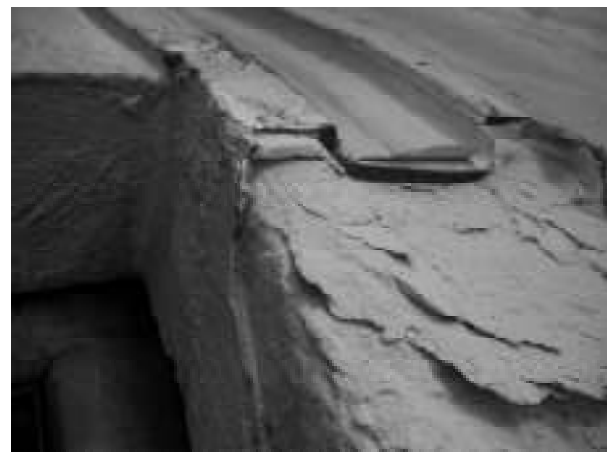
Figure 4. View of cement mortar layer between stone and lime mortar layer

apparent prior intervention, S2 (Fig.4) of stone beneath and around intervention with cement mortar

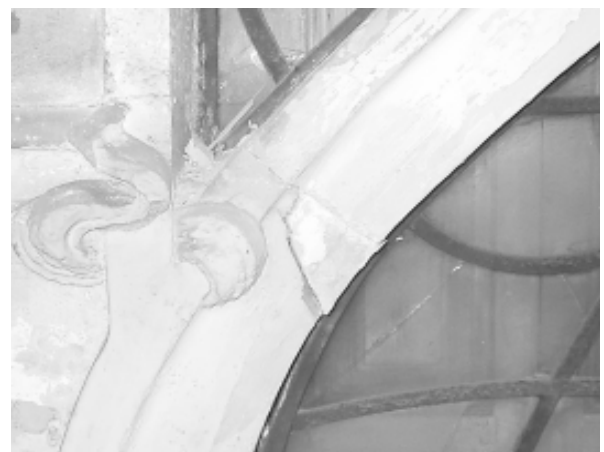
cracking (Fig.5) and granular disintegration (Fig. 6) (NORMAL, 88).

Figure 5. Cracking

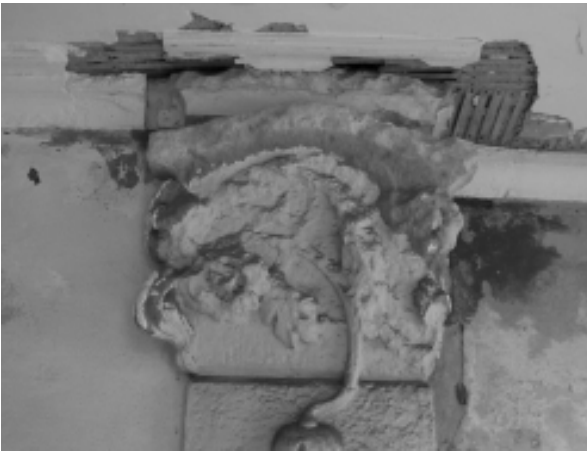
Figure 6. Disintegration

The simultaneous presence of the minerals thenardite and mirabilite at disintegration sites, indicates that a transition between hydrated and non-hydrated phase might have a strong influence on decay. Some authors maintain that damage is caused by thenardite dissolution and precipitation of thenardite and mirabilite at temperatures below 32.4°C (Rodriguez-Navarro 2000, Tsui 2003), in accordance with Aveiro's temperature range.

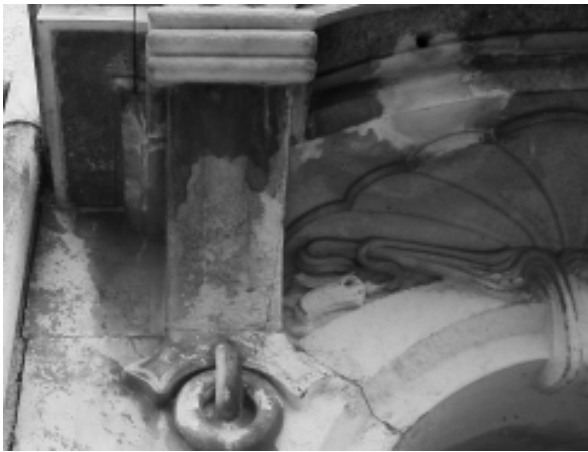
On the main façade, which overlooks the road, column capitals and corbels have evident black crusts (Figs 7 and 8).

Figure 7. Black crust

- black crusts on the façade (surface samples), representing two distinct zones: S4 withdrawn from below the balcony (Fig. 7) and S5 collected from a decorated stone capital (Fig. 8)
- columns with accentuated sanding on the rear façade (S6, Fig. 9)
- granite scaled stone on the rear façade (S7)

Black crusts are mainly composed of calcite and gypsum. Sample S4 contains thenardite and sample S5 contains anhydrite. As AAS was not performed on these samples, their nitrate content is unknown. However, the location of the house and mineralogic composition of crusts suggest a pattern similar to that of calcareous stones subject to air pollution and

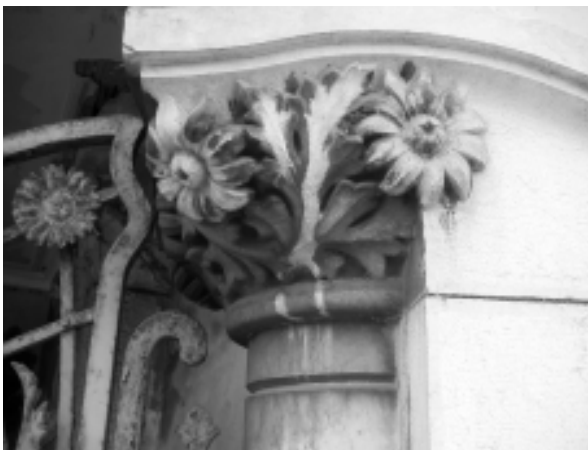
Figure 8. Black crust

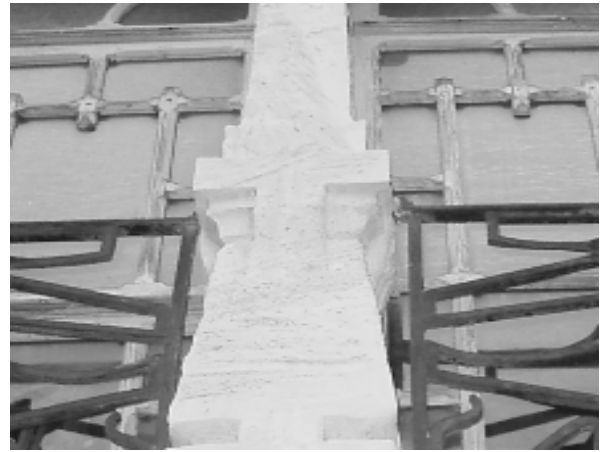
The rear façade, leading to a small garden is not as richly decorated as the front. The use of stone is less abundant: calcareous stone was used on the first floor, surrounding windows (Fig. 9) and granite was used on the ground floor around doors. Both show signs of decay, as columns exhibit sanding and the granite is scaling.

Figure 9. Column granular disintegration

Chemical analysis also confirm a high quantity of soluble salts in stone, mainly as sulphates, chlorides and nitrates. This was particularly evident for sample S6, in which only calcite was found using XRD, but which shows the highest SO₄ content, indicating the presence of soluble salts.

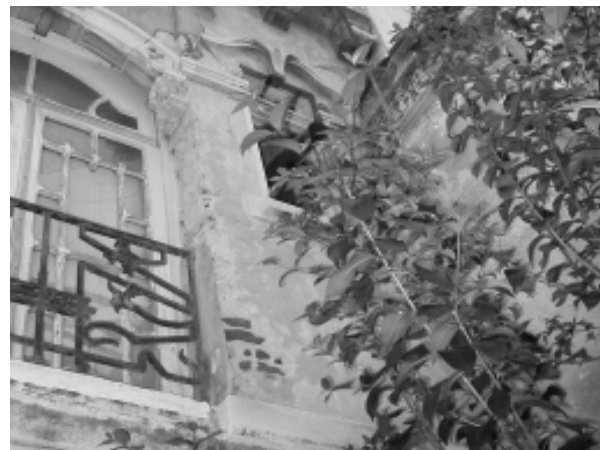
Mortar was used as a render both in the exterior and interior, over extremely heterogeneous walls, made from adobe, burnt brick and panelled walls filled with earth and lime. Renders on the main façade are in a good conservation state. However, this is not the case on the other side of the building, where the render is sometimes missing (Fig.10) and where cement mortars have been used as replacement mortars in some cases.

Figure 10. Areas of missing render

Mortars were briefly characterized for possible substitution, which may be necessary due to their high salt content.

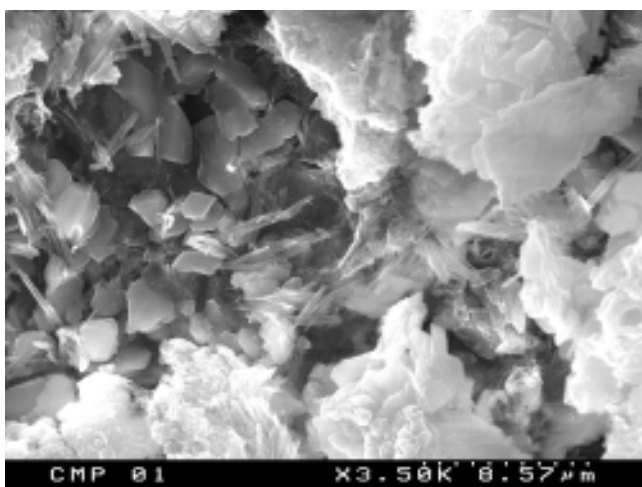
These analyses show the existence of a considerable amount of soluble salts in the exterior mortar M3, mainly chlorides and sulphates. This is also expressed in the XRD analysis, by the existence of gypsum, anhydrite, thenardite and carnallite in the various layers of the exterior mortar. Interior mortar M4 has few soluble salts and in mineralogical terms, it has the composition of a usual mortar with a calcareous binder.

Analysis of samples by SEM allowed clear identification of crystallized salts, such as the presence of gypsum needles in mortar M2 (Fig. 11).

Figure 11. Presence of gypsum in mortar M2
