Repair mortars for a maritime fortress of the XVII th century

In the present paper a study developed in Laboratório Nacional de Engenharia Civil (LNEC) about the rendering mortars of a XVII th century Fortress nearby Lisbon, placed at the Atlantic Coast close to the Tagus river estuary is presented. A brief description of the building and its History is made, the main defects observed in renders are referred and experimental *in situ* applications of several different renders and paintings are described. The tests carried out to verify their efficacy and their compatibility with old masonry and environmental conditions are also presented.

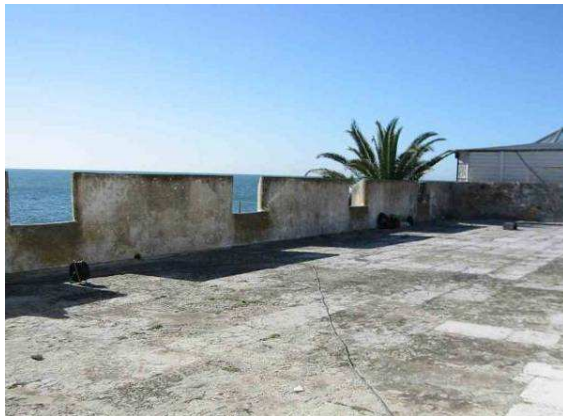
Fig. 2 Appearance of the fortress wall covering

Structurally the fortress presented a good state of conservation. The battlements, composed by stone and brick irregular masonry, are very thick and presented a red-tile colour, due to the ancient lime mortars that incorporate local earth of a reddish colour. However, the surfaces of façades and battlements were uncharacteristic, as a part of the ancient mortars were substituted by new cement based mortars, evidencing several defects (figs. 2 and 3) (table 1).

Local	Defects	Probable cause
External wall surfaces	Renderings	<ul style="list-style-type: none"> ▪ High relative humidity of the region; ▪ Direct aggression of the sea and salty sprinkle, bringing high salt content from the foundations and walls materials and from the air itself; <ul style="list-style-type: none"> ▪ Absence of drainage; ▪ Absence of solutions for protection and for transport of rain water; <ul style="list-style-type: none"> ▪ Absence of regular maintenance.
	Loss of cohesion, erosion, loss of adhesion, parasite plants, moist, biologic colonization, detachment, cracking, and generalised dirt.	
	Paintings	
	Detachment, loss of cohesion, cracking, and generalised dirt.

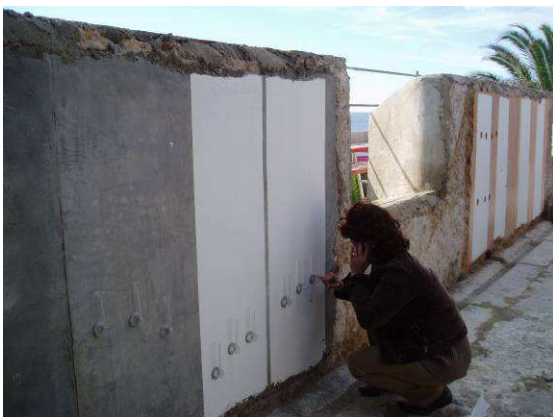
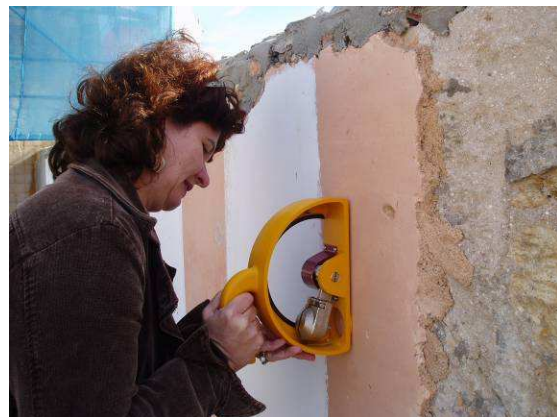
Fig. 4 – Experimental applications and tests *in situ*

Experimental applications of four possible substitution mortars were carried out on a battlement of the fortress. Some of the panels were painted with two types of paint hypothetically considered compatible with the renders: a silicate paint and a siloxan paint. The objective was to observe any defects or difficulties and to perform *in situ* tests on the different solutions, in order to choose the most adequate (fig. 4).

- The analysis of the test results on the paintings (table 6 and fig. 4), together with data from previous studies (Tavares et al, 2002; Veiga and Tavares, 2002) pointed out to the recommendation of the silicate paint. This paint seems to present a consolidant effect on the render, evidenced by slightly higher values of durometer and Schmidt hammer measures, and it contributes for water protection favouring simultaneously an easy drying. Concerning the siloxan painting, the results of the tests *in situ* were not unfavourable, although the consolidant effect was not noticeable, but the inexistence of laboratory studies for now was considered a negative factor.

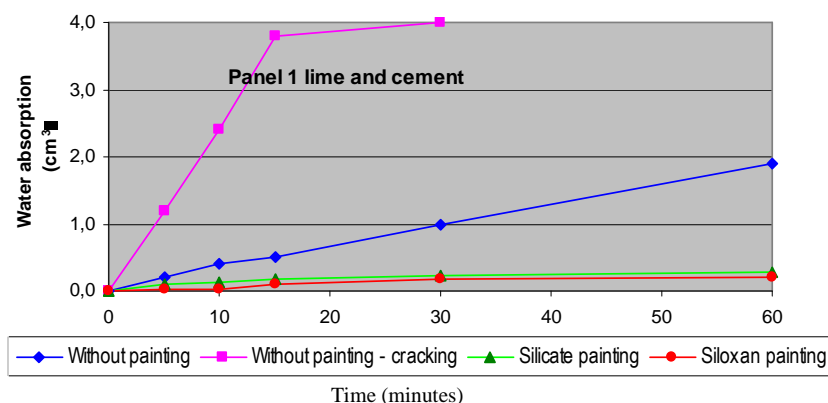
Fig. 5 - Graph of the Karsten tubes tests on panel 1 with painting

This test consists in measuring the quantity of water absorbed by the wall surface, through the render or the painting, using small graduated tubes full of water applied on the wall (Magalhães et al, 2005).

The test results are presented in tables 3 to 6 and in fig. 5
