Development of Artificial Ageing Tests for Renders – Application to Conservation Mortars

A L VELOSA¹ and M R VEIGA²

ABSTRACT

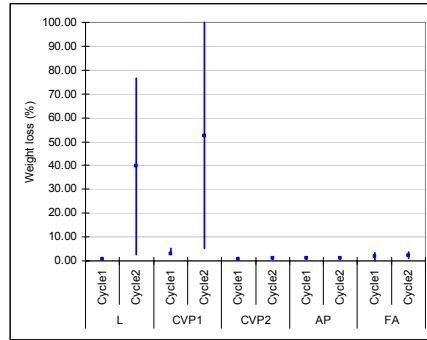
Figure 4 Weight loss of mortar (%) after rain-heat cycles (Cycle 1) and freeze-thaw cycles (Cycle 2)

Results of the artificial ageing test are represented in Figure 4, with the percentage weight loss of mortar after each cycle (medium and standard deviation). Hardly any weight losses are observed after the first rain-heat cycle and the behaviour of mortars to this type of weathering is generally good. Freeze/thaw cycle, much more aggressive to mortars, produced greater differences in results. Although most mortars also had small mass losses after freeze/thaw was performed, one of the Lime mortars lost its superficial layer and the borders were eroded and one of the Cape Verde pozzolan mortars (1:0,5:2,5 ratio) detached itself completely from the substrate. This is depicted by the great standard deviations observed in Figure 4. The failure observed in the mortar/brick interface may be due to

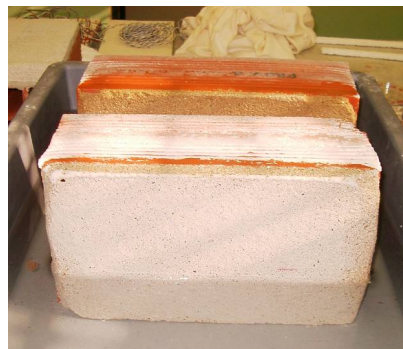
Figure 6 Degradation pattern of specimens after first cycle

Resistance to salts was monitored by placing specimens in the same conditioned atmosphere (20°C, 65%RH) in a tray with water containing 27g/l of NaCl (simulating sea water) and reaching a height correspondent to half of the specimen (Figure 6). In this way specimens are at the same time in direct contact with water and there is a capillary absorption phenomenon taking place. On the other hand, soluble salts from the brick can migrate to the mortar. Specimens were kept during one week in these conditions and then dried at ambient temperature until they reached constant weight. Cycling was performed until degradation was evidenced by a weight loss.

Salt resistance testing produced a common pattern of salt precipitation, as seen on Figures 6, 7a and 7b. Salt crystallized on the uppermost brick surface, where it was brought to by capillary action. Most mortar degradation occurred on mortar borders contiguous to this surface, but the brick itself suffered severe degradation, especially innermost and on the zone that was never immersed.

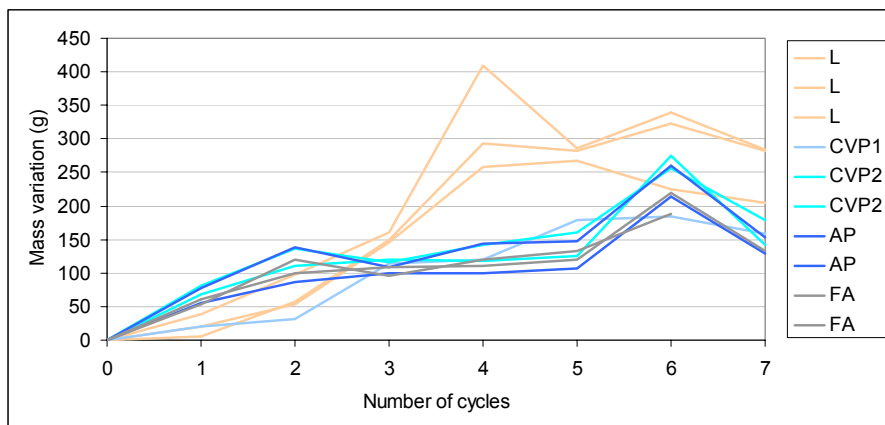
Figure 8 Mass variation (%) during salt cycles

Analysing the mass variations (Figure 8), it is evident that specimens with greater curing times (L and CVP1) have a slower initial mass gain, in comparison with other specimens, cured for 90 days. On the long term, aerial lime mortar specimens (L) have a more erratic behaviour and the highest mass gains, due to salt crystallization. Mortars CVP2, AP and FA show similarities, with an especially big mass gain after the sixth cycle was performed, related to salt crystallization, followed by a mass loss due to degradation of the specimen (mortar and brick). The behaviour of CVP1

is particular, due both to its age and composition. This specimen shows the smallest variations during the salt cycling. One of the mortars with Fly Ash detached itself from the brick during the seventh cycle; this may be due to salt formation on the brick/ mortar interface and/or lack of adhesion between mortar and brick.
