Consolidation of renderings simulating stone in the façade of LNEC's building

SUMMARY: The main façade of the building of Laboratório Nacional de Engenharia Civil (LNEC), is covered by a rendering simulating stone, composed by air lime and calcareous aggregate, using a special technique, assigned in Portugal, as marmorite. This rendering was applied in the fifties of the XXth century and in the beginning of 2006 presented some degradation, at material and aesthetic level, demanding a conservation intervention. This paper reports the study carried through for the consolidation of these renderings; it gives information about the rendering technique, presents a set of tests to evaluate the effectiveness of the consolidation products, analyzes the results obtained and describes in-situ application, including the techniques used.

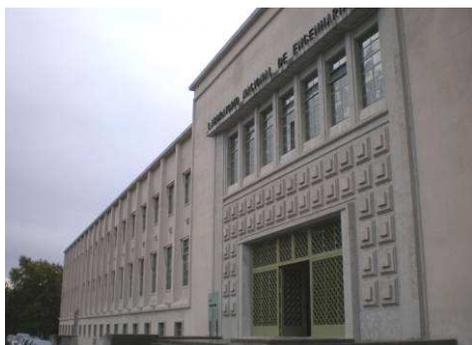
Fig. 1 – General view of the main façade of LNEC.

The main building of LNEC, of late modernist style, was designed by the portuguese architect Porfírio Pardal Monteiro and constructed in 1950-52. The main façade of the building is covered by a rendering simulating stone, assigned as marmorite, composed by air lime and calcareous aggregate (fig. 1, table 1 and 2). This kind of render was used in the region of Lisbon and South of Portugal on the fifth to seventh decades of XXth century. It was obtained by water spraying of the rendering surface during the hardening process, to remove the superficial binder and let the aggregates on sight.

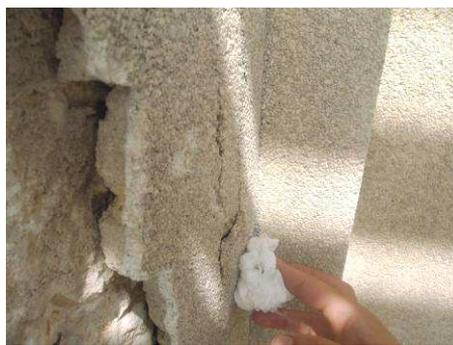
The anomalies observed on this rendering were: i) loss of cohesion, consisting in loss of mechanic resistance of mortar's layers due to loss or alteration of the binder among particles, provoking several defects, such as peeling, desegregation, and powdering; ii) loss of adhesion, consisting on the separation or detachment that can occur in different layers of a mortar or between mortars and the support, provoking defects such as detachments, cracks and lacunae (fig. 2). These problems were observed only on a few zones of the rendering, and were not considered very serious, however they should be treated. The treatment required the use of several products and distinct techniques of consolidation [3].

Fig. 2 – Detail of a zone with detachment.

Application of the hydraulic lime grout – Previously the zone of detachment was humidified with a mixture of water and alcohol, to favour the grout penetration. The product was then applied, with a manual syringe, being the first layers slightly more fluid than the following layers, to allow a better penetration, until filling the emptiness (fig.8).

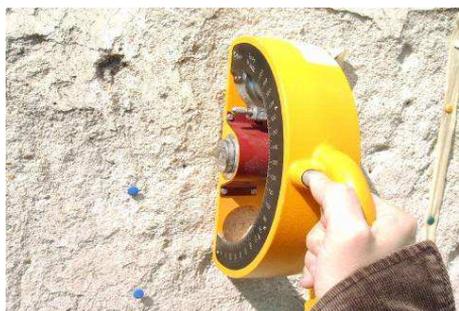
Fig. 3 – Test with Shmidt impact hammer on ancient lime mortar

Evaluation of the mechanical resistance *in situ* and in laboratory: the results obtained at *in situ* tests with Shmidt impact hammer, and durometer, and at laboratory test (flexural and compressive strength) demonstrated an increase of resistance on the mortars superficial layers after treatment (table 5).

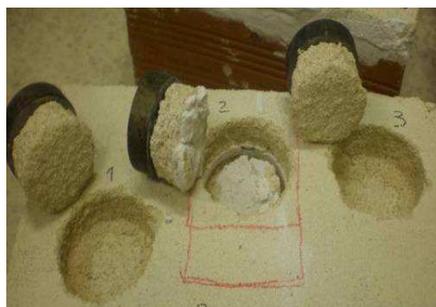
Fig. 4 – Pull-off test in laboratory

Evaluation of the mechanical resistance: the Flexural and Compressive tests proved that the grout presents an increase of strength and a higher modulus of elasticity than the lime mortar used as a substrate; however the values are moderate (table 3 and table 6). The pull-off test showed that the grout has resistance similar to the substrate (zone without grout, table 6). The rupture occurred in the grout mortar (fig 3), meaning that the grout's tensile stress is lower than the adhesive strength between mortar and substrate. The observation of the rupture surface of the pull-off test showed that the grout filled uniformly the hole provoked in the Specimen developed for the effect (fig 4).

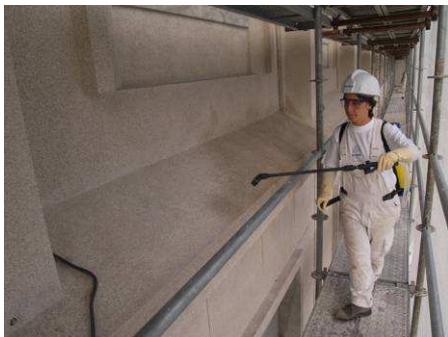
Fig. 7 – Lime water application in building

Application of limewater - The product was applied on the rendering, using the spray technique with a manual spray, from a distance of 50 cm, in the end of the day, at 25°C T and 55% HR. The application was interrupted when it was verified that the rendering was

completely damp. This saturation effects happened approximately after 15 applications (fig.7).

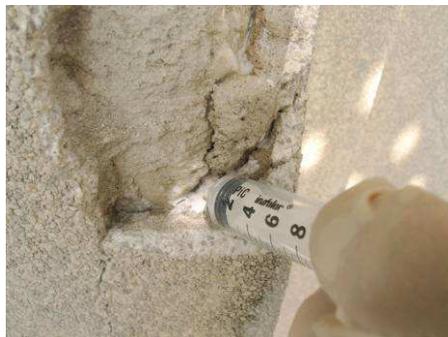
Fig. 8 - Grout application in building.
