# Conservation of old renderings - the consolidation technique through traditional and sustainable materials: the lime water (a study methodology)

Martha Lins Tavares

M<sup>a</sup> do Rosário Veiga

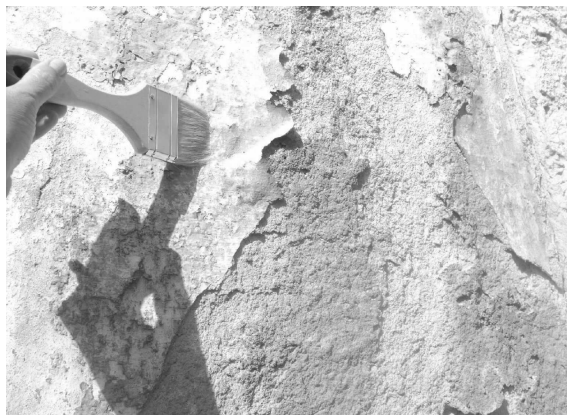
- loss of cohesion, that is the loss of the mechanic resistance of mortar's, layers due to loss or alteration of the binder among particles, provoking several defects, such as: peeling, desegregation, pulverulence, etc. (Fig. 1)
- loss of adhesion, that is the separation or detachment that can occur in the different layers of a mortar or between mortars and the support provoking defects such as: detachments, cracks and lacuna.

Figure. 1 Plaster whit loss of cohesion

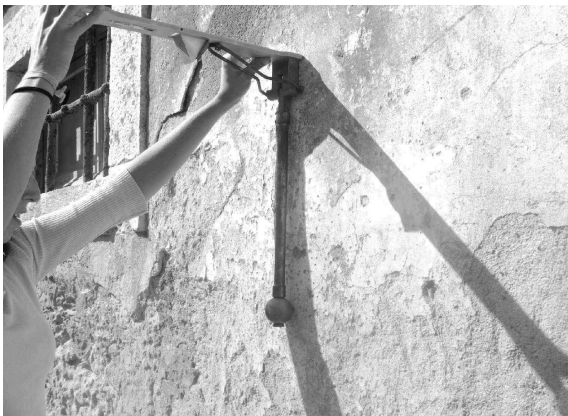
- Cohesion tests - the superficial cohesion of plasters and painted surfaces is evaluated before and after the consolidation treatment (Fig 4) (VEIGA, 2000).

Figure 4 Sphere Shock test

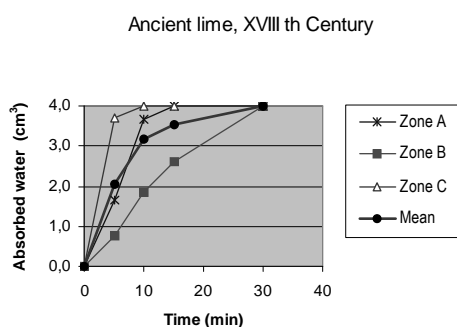
In tables 1 and 2 and Fig. 5 the main results obtained before the application of the consolidants are summarised, thus informing on the state of current conservation of these renderings.

Figure 5 Evaluation of the permeability to water under low pressure

- The tests on ancient mortars with the Karsten tubes showed that they are extremely permeable to water and, as verified with *Strip tests*, they do not contain soluble salts. It is important to verify the changes on permeability to water induced by consolidation treatments and to assess if consolidants don't introduce any salts in the mortar.
- The results obtained at *in situ* tests of Sphere impact and Controlled penetration showed some differences: lower deformability and higher re-
