## **Grouting mortars for consolidation of historical renders showing loss of adhesion**

**Abstract** - Loss of adhesion is one of the main forms of degradation of old renders, in the form of separation of different render layers or between render and substrate, producing anomalies, such as debonding, detachment, cracks and lacuna on the render. In the present paper a study developed at LNEC – National Laboratory of Civil Engineering of Portugal – is presented, concerning restoration techniques for historical renders by consolidation using grouts for adhesion restitution. Lime grouts for consolidation should be mechanically, physically and chemically compatible with the original render, as this is a practically irreversible treatment. The aim of the study was the discussion of characteristics of grouts, considering both compatibility and efficacy. Several grouting mortars are selected, the methodology of the study and the laboratory tests carried out are described, as well as the critical analysis of the results, and the conclusions are summarized. Some proposals for future research are also presented.

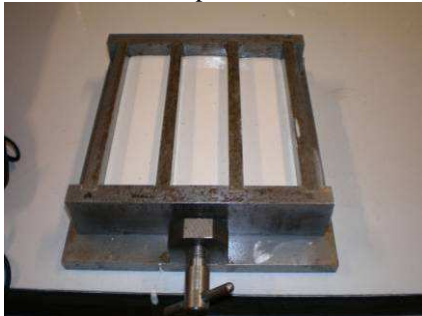
- Prismatic specimens of grout mortars (40mm x 40mm x 160mm) (Fig. 1).
- Specimens constructed to simulate the loss of adherence with a “detachment” between layers in laboratory [3] (Fig. 2). These specimens were prepared with red perforated bricks rendered on one side with two layers of lime mortar (volumetric proportion lime:sand of 1:3), with total thickness of 20 mm. One

**Fig.1** Preparation of prismatic specimens of grout mortars.

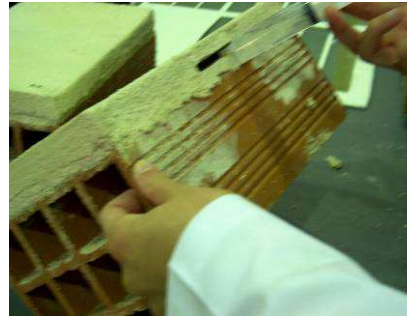
layer with 10 mm was applied and then a plastic ruler was placed on it before the application of a second layer. This ruler was used to simulate a void area between the two layers and was then removed after the render dries. Three months later the void area was humidified with a water and alcohol solution, to facilitate the grout penetration. The grout was then injected, at first with a very fluid consistency, in order to facilitate the complete filling of the hole. After the treatment, the specimens were placed in a conditioned room at  $23\pm 2^{\circ}\text{C}$  temperature and  $50\pm 5\%$  RH.

**Fig.2** Specimens simulating the “detachment” between layers

- **Adherence:** the pull-off test showed that grout mortars have similar strength as lime render mortar (zone without grout, fig. 2). On mortar A the rupture occurred through the support (fig.6), meaning that the grout's tensile stress strength is higher than the render's strength, although the test could be performed on one specimen only and more experiments should be carried out to confirm this result. In mortar B the rupture occurred through the grout (fig 5) meaning in this case that grout's tensile strength is lower than the cohesive strength of substrate's mortar and than the adhesion strength between grout and render.

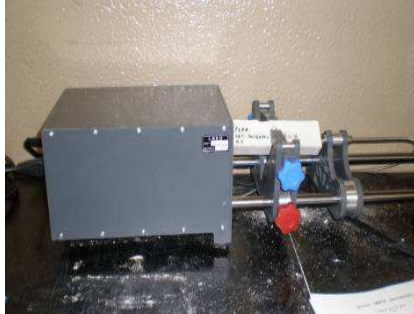
- Flexural and compressive strength – evaluate the mechanical resistance of grout mortars (NP EN1015:11).
- Dynamic modulus of elasticity – evaluates the deformation capacity of grout mortars (method of the resonance frequency – LNEC Report 427/05-NRI [5] and NF- B10-511) (Fig. 3)
- Pull-off test – evaluates the adhesion strength of grout mortars to the render (EN – 1015-12:2000). (Figs. 4, 5 and 6)
- Shrinkage – evaluates the shrinkage of grout mortars, by comparing the variation between the initial (mould dimensions) and final (after curing) dimensions.
- Rheology – evaluates the grout behaviour in fresh state, through a relation between the product flux and deformation.

**Fig. 3** Determination of dynamic modulus of elasticity.

The deformation capacity was evaluated through the dynamic modulus of elasticity of prismatic grout mortars, determined by the frequency of resonance method. The method consists on submitting the specimen to high frequency waves, varying the frequency and identifying the resonance frequency through the peak of amplitude. The resonance frequency is similar to the natural frequency of the specimen and thus it is possible to use it to determine the dynamic elastic modulus. The results are presented in table 2.

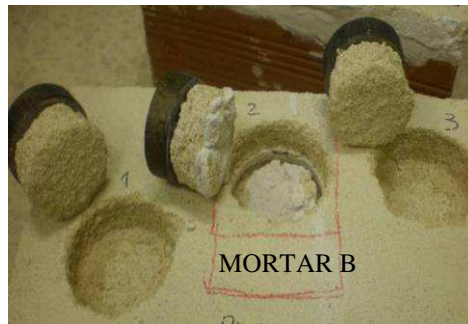
**Fig.5** Specimens after pull-off test – mortars B.

- **Void area filling:** The observation of the rupture surface of the pull-off test on grout mortars A and B, showed that the hole in the specimens was uniformly filled (figs 4 and 5). On mortar C voids and some cracks were found (fig. 4) with a powdered appearance, possibly due to incomplete carbonation.

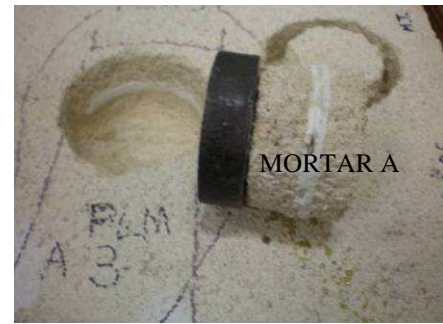
**Fig.6** Specimens after pull-off test – mortars A.
