Characterization of Stone and Mortar Decay – Casa Major Pessoa, Aveiro

ABSTRACT: Casa Major Pessoa is one of the most remarkable *Art Nouveau* buildings in the city of Aveiro, a town that is especially well known in Portugal for its heritage representative of this artistic style. This house was private property until recent years and when it became vacant its decay process began, favoured by enclosure and lack of maintenance. Recently, the building, classified as of Public Interest, was bought by the Town Hall in order to create an *Art Nouveau* Museum. The severe degradation present throughout the house and specifically on its richly decorated façades led to a study investigating the state of decay of different materials. Samples were extracted from exterior stone elements, both interior glaze-supporting mortars and exterior mortars. Analysis included x-ray diffractometry (XRD), atomic absorption spectrometry (AAS), and scanning electron microscopy (SEM) performed both in stone and mortars. Results revealed the presence of salts in most samples, with a prevalence of thenardite and gypsum. Their presence can be attributed to the action of maritime aerosol, combined with traffic po

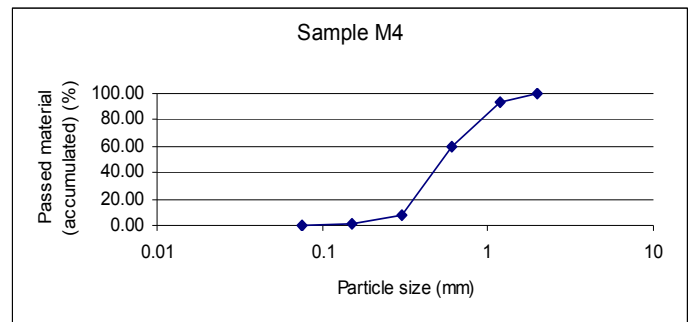
Figure 12. Particle size distribution of mortar M4

Acid etching provided binder/aggregate ratios (in weight) of 79/21 and 71/29 for mortars M3 and M4, respectively. Similar patterns of particle size distribution were found on both samples and results for sample M4 are shown in Figure 12.
